REPORT OF MARINE SURVEY
OF THE VESSEL

Dowager

1931 *Mathews* 38 ft. Double Cabin Cruiser

June 16, 2017

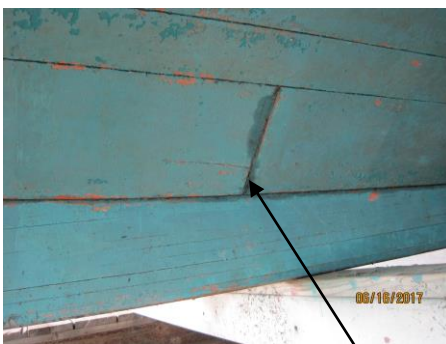
C 1 The starboard garboard has a 5" split.

5 in. split in garboard – starboard

I recommend monitoring for a future repair.

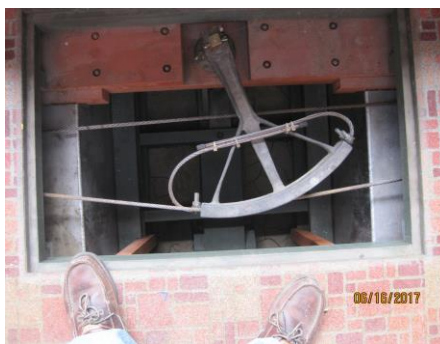
B1 The Steering Cable is loose at the quadrant.

Steering Cable loose at Quadrant

I recommend adjustment.
